Combined Ex-situ and In-Situ Remediation of Soil and Groundwater Impacts to Meet Site Closure Requirements

*Presented by:
Robert Tossell*

April 2010

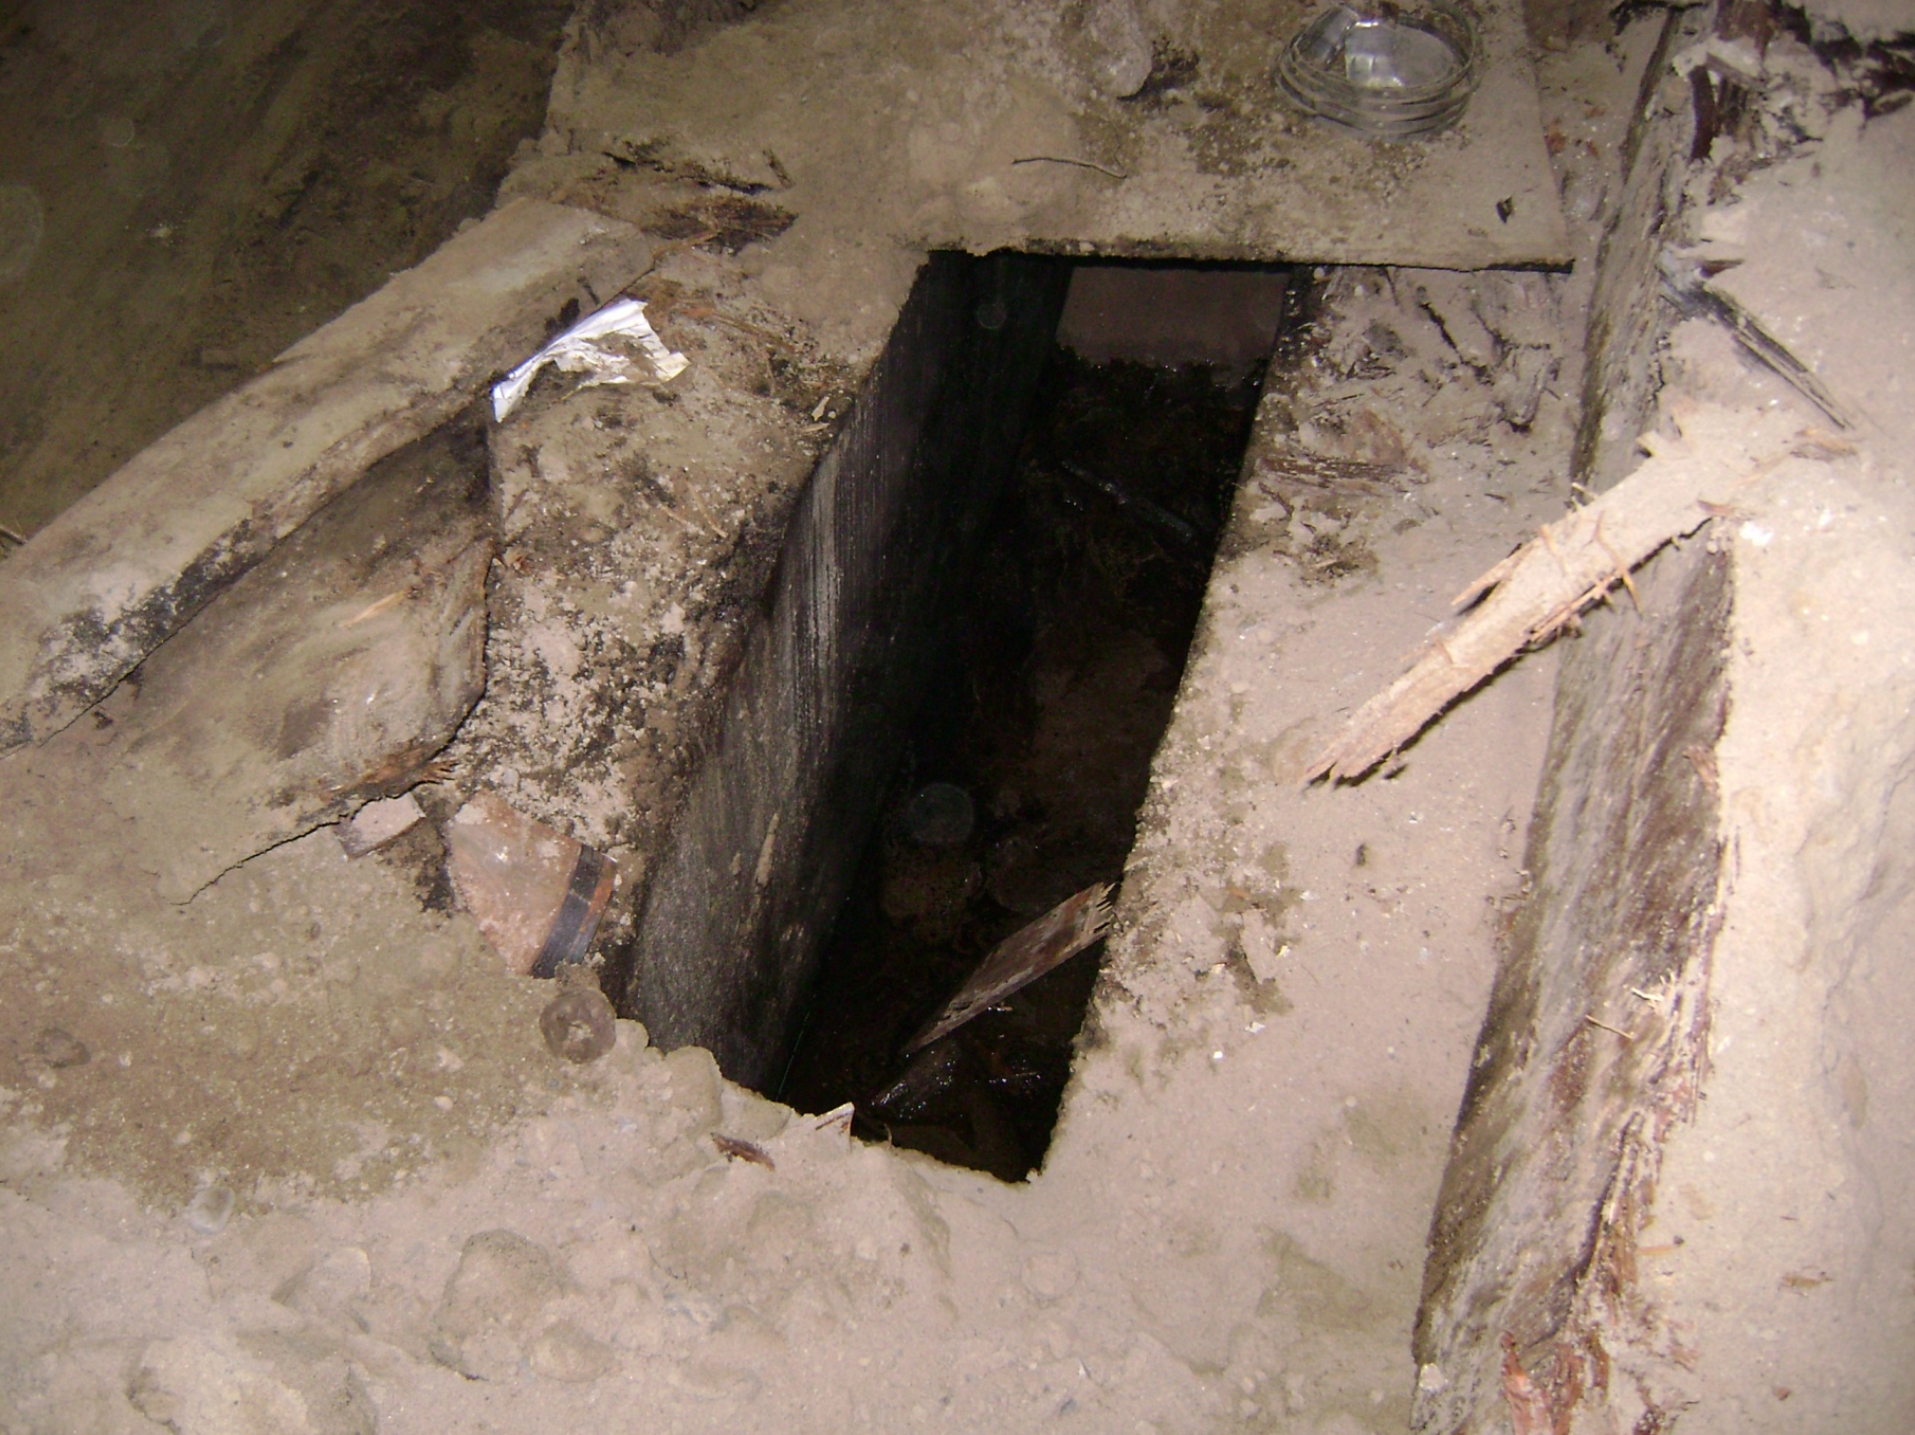
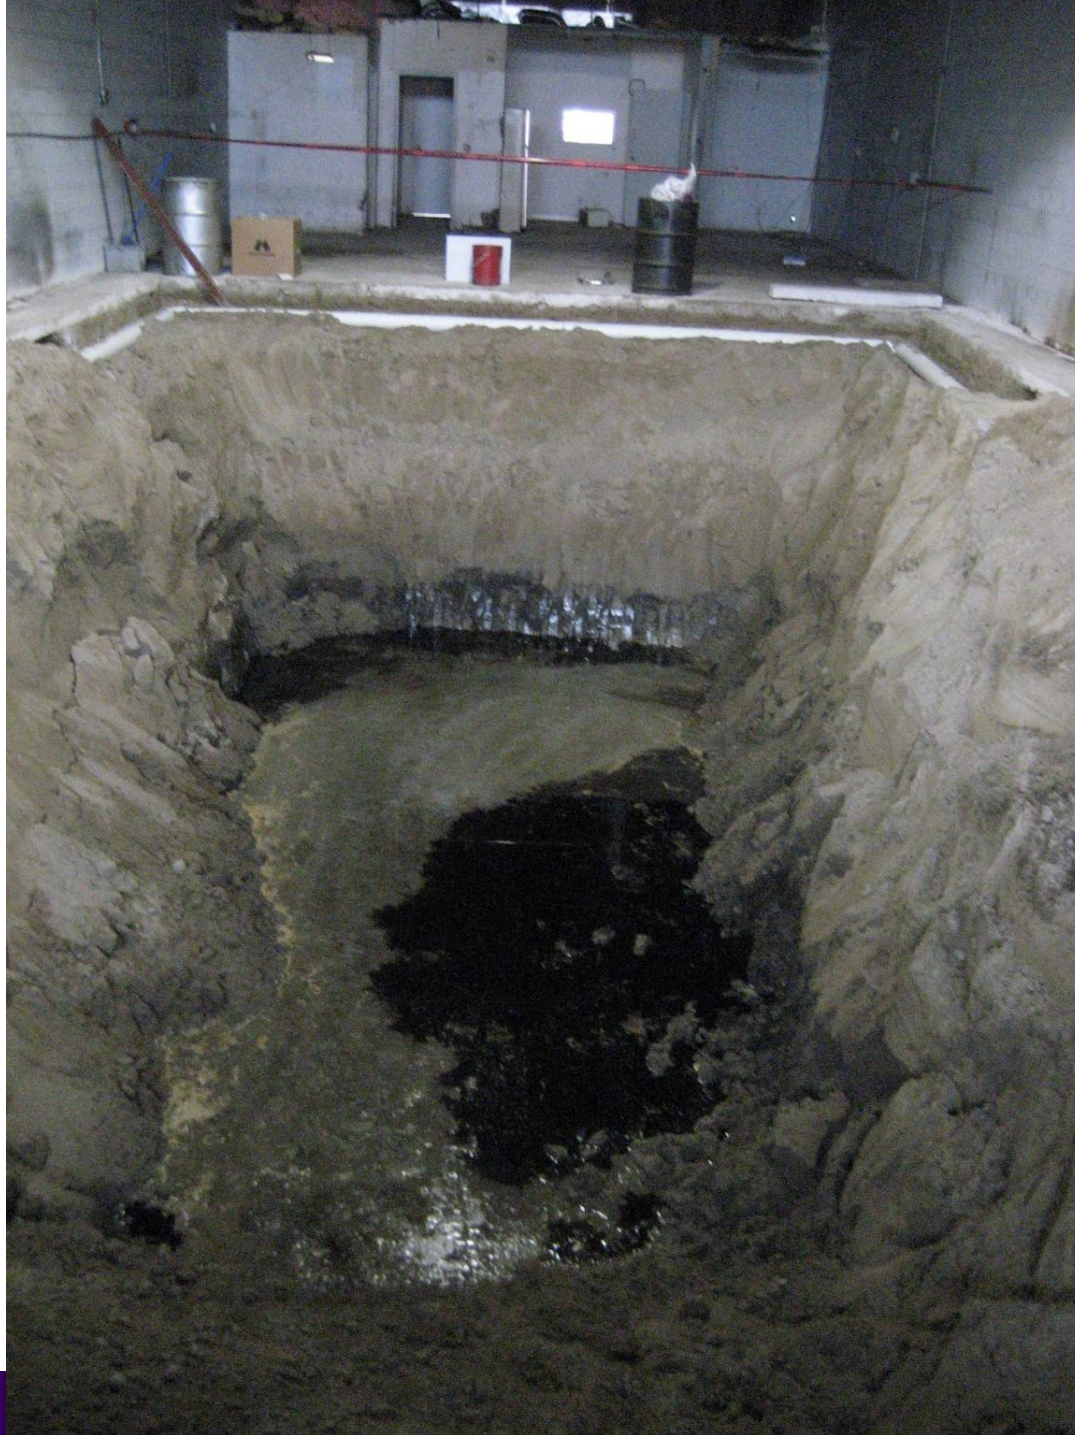
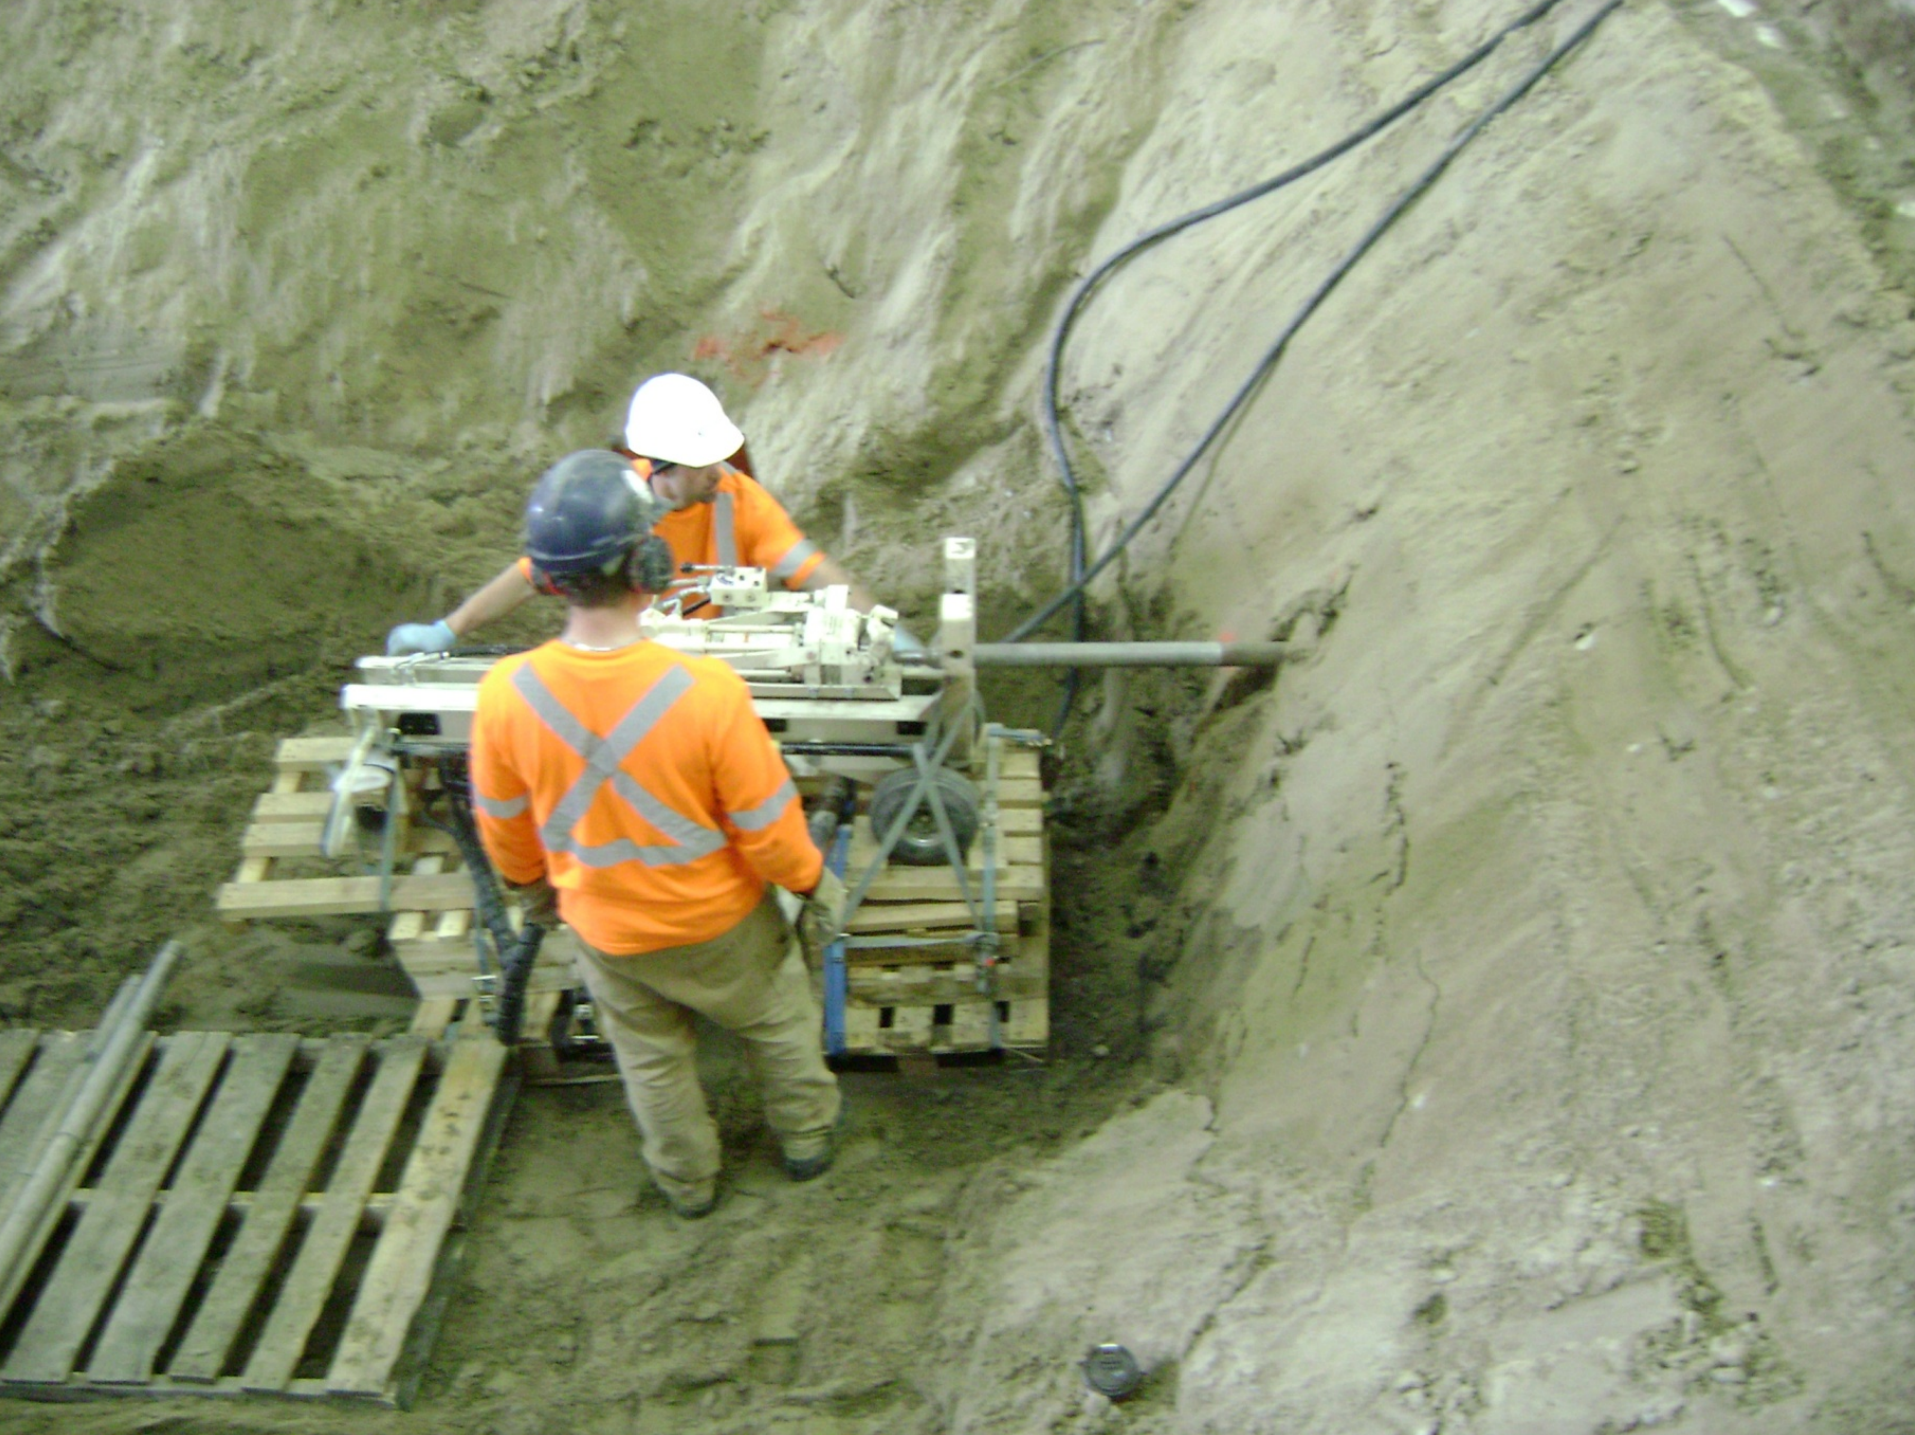
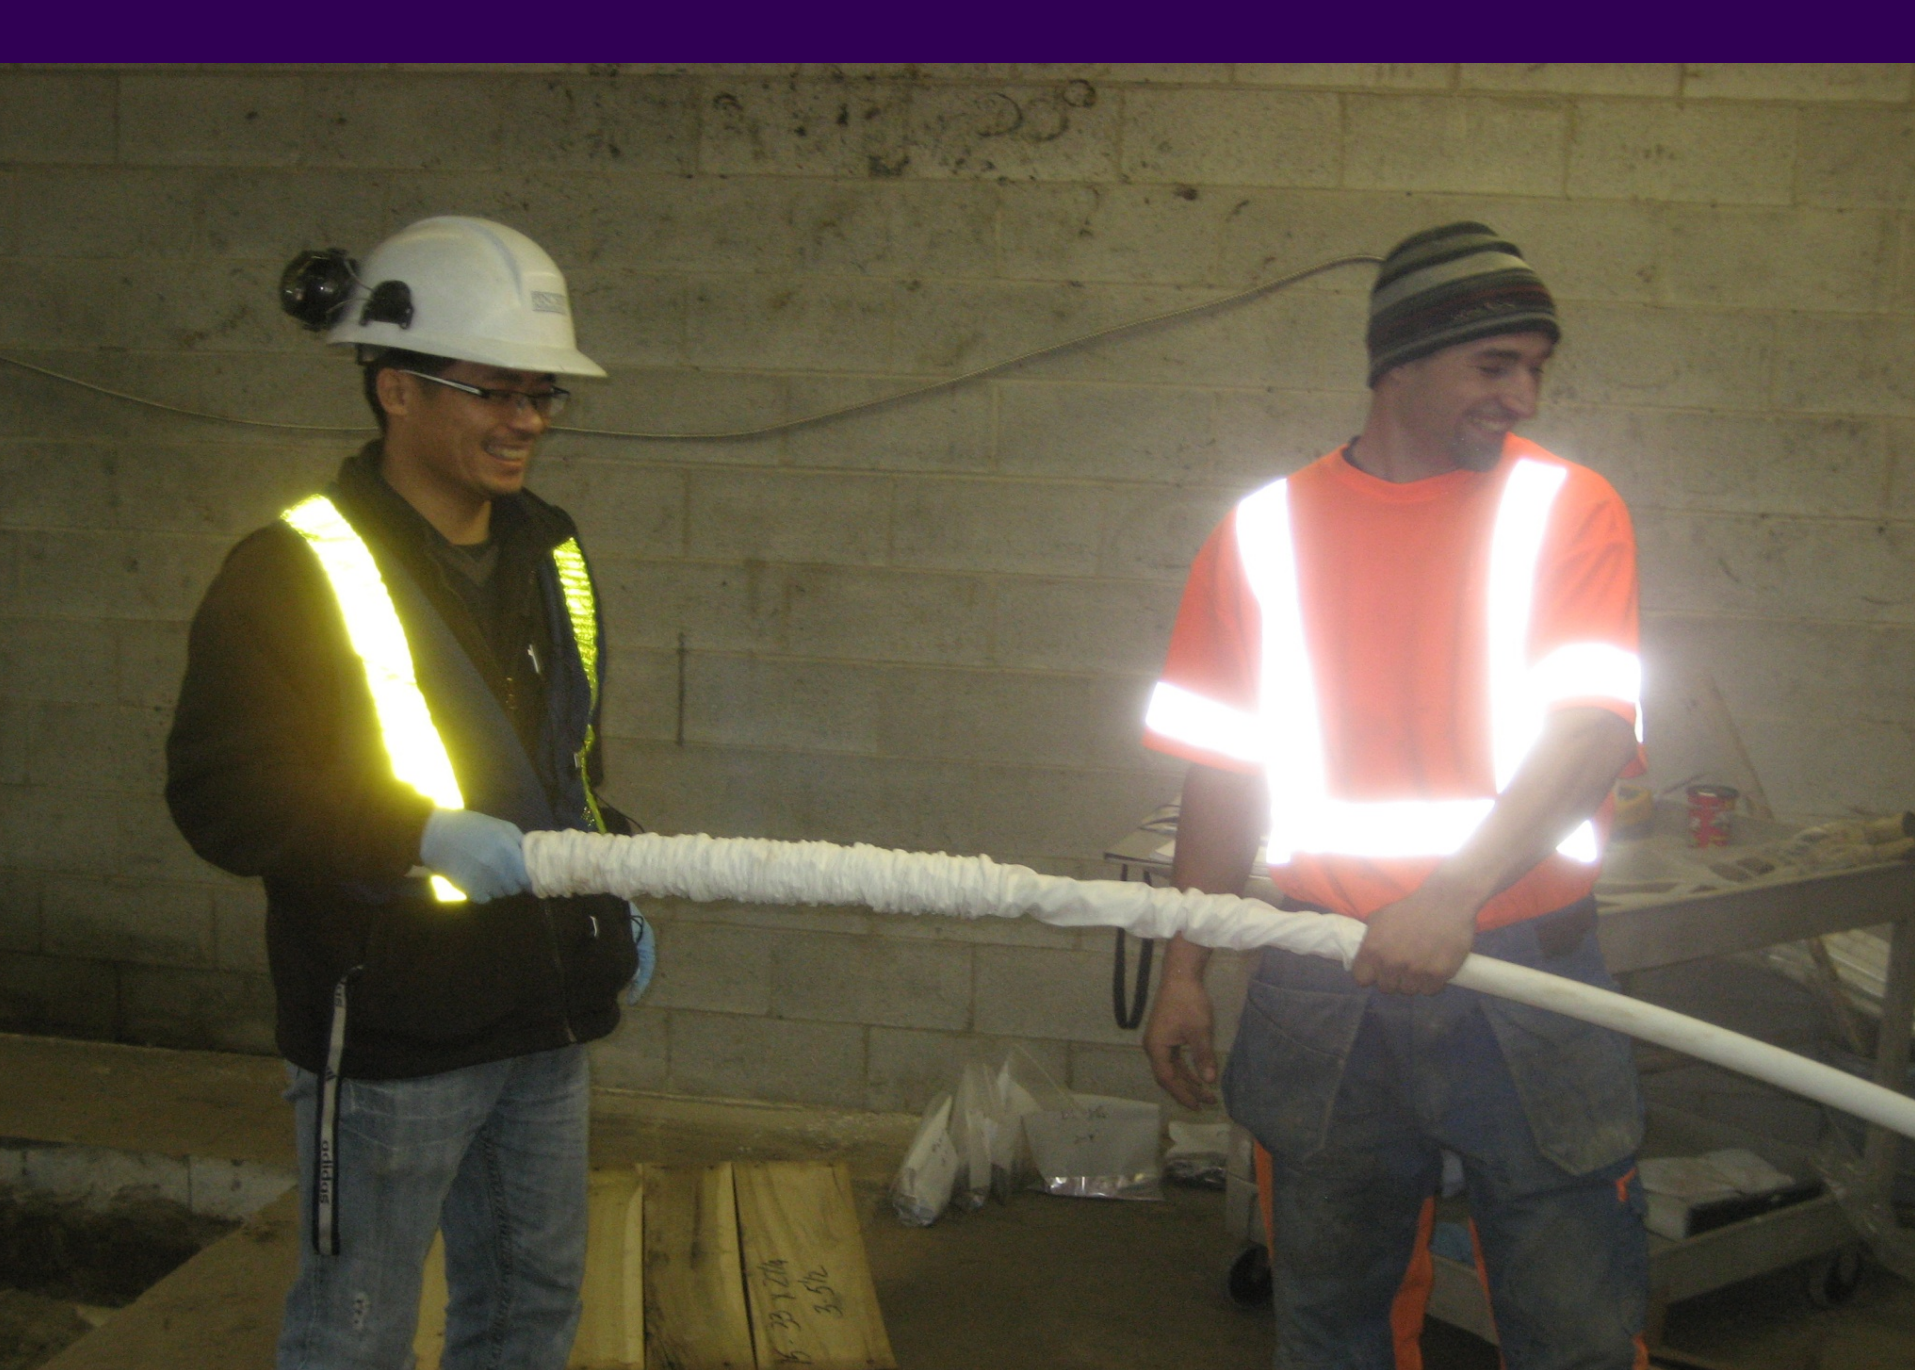
Implementation - Site 2

- Soil excavation late March 2009
- Permanganate injection in bottom of excavation to treat residual chlorinated solvents (2009)
- Installation of horizontal substrate delivery system April 2009
- Product recovery system installation date (fall 2009)
- MNA monitoring began in May 2009
